# Manhole Inspection Summary

Manhole # S17M\_\_011MH

Insp Date: **4/16/08 9:12 AM**

**Location** Address: **2501 frederick ave** Cross Street: **franklintown rd**

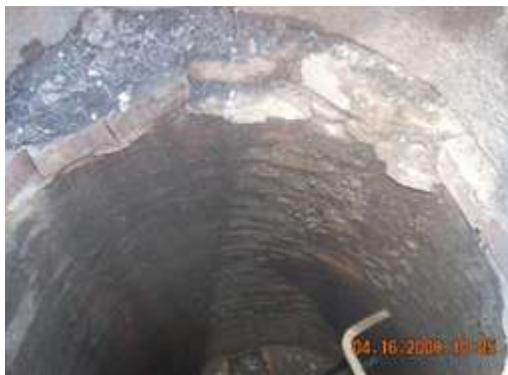
Defect 4

**Frame** Offset: **4** (in.) Condition: ☐ Sound ☐ Cracked ☒ **Leaks**

Infiltration: ☐ None ☒ **Joint** ☐ Cracks ☐ Mortar ☐ Roots ☐ Wall

infiltration @ chimney joint and frame

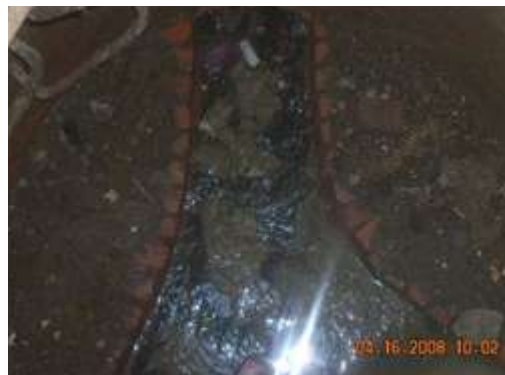
Defect 3

Condition: ☐ Sound ☐ Cracked ☐ Root Intrusion ☐ Deteriorated ☐ Leaks ☒ **Debris**

debris in channel, and on bench

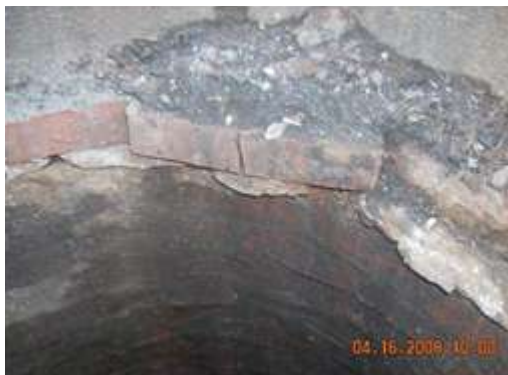
Defect 2

Condition: ☐ Sound ☒ **Cracked** ☐ Root Intrusion ☐ Loose Brick ☐ Deteriorated

cracked chimney brick

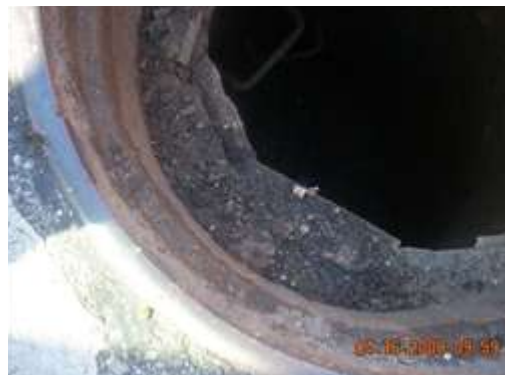
Defect 1

frame offset

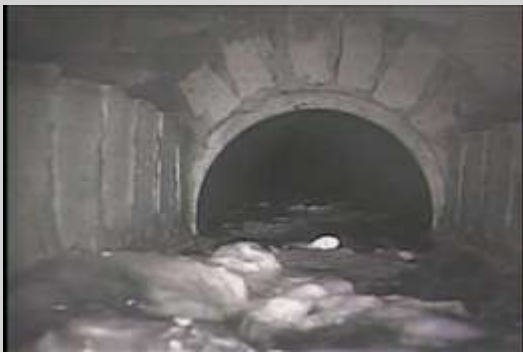
12 O'Clock Outflow

10 in. Circular Gravity Sewer  
Pipe Out @ 12 O'Clock

Pipe Height: **9.6** (in.) Rod and Bar (Angled)  
Pipe Material: **Clay** ☐ Pipe Lined  
Invert Depth: **9.89** (ft.) Flow Characteristics: **Slow**  
Deposits: ☐ None ☐ Mud ☒ ~~Sludge~~ **Debris** ☐ Grease  
Silt Depth: **4** (in.) Deposits Extent: **Medium**  
Infiltration: **None** Pipe Seal Cond: **Sound**

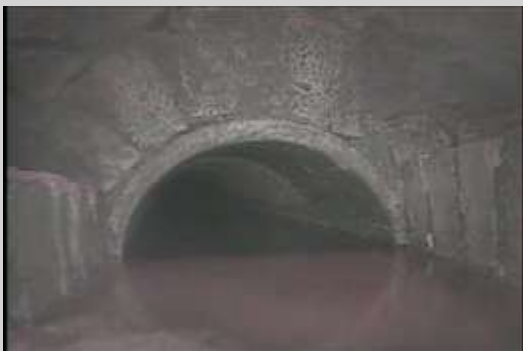
4 O'Clock Inflow

8 in. Circular Gravity Sewer  
Pipe In @ 4 O'Clock

Pipe Height: **9.6** (in.) Rod and Bar (Angled)  
Pipe Material: **Clay** ☐ Pipe Lined  
Invert Depth: **9.80** (ft.) Flow Characteristics: **Slow**  
Deposits: ☒ None ☐ Mud ☐ ~~Sludge~~ ☐ Debris ☐ Grease  
Silt Depth: **0** (in.) Deposits Extent:  
Infiltration: **None** Pipe Seal Cond: **Sound**

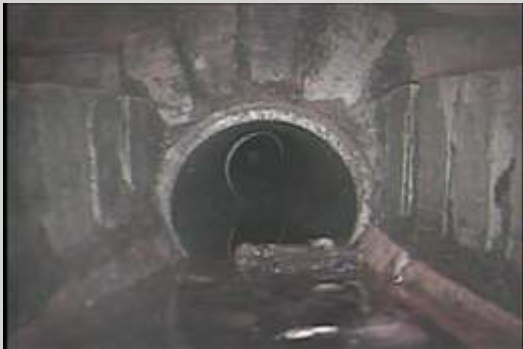
7 O'Clock Inflow

6 in. Circular Gravity Sewer  
Pipe In @ 7 OClock

Pipe Height: 6 (in.) Rod and Bar (Angled)  
Pipe Material: Clay ☐ Pipe Lined  
Invert Depth: 9.45 (ft.) Flow Characteristics: Slow  
Deposits: ☐ None ☐ Mud ☒ Sludge ☐ Debris ☐ Grease  
Silt Depth: 2 (in.) Deposits Extent: Light  
Infiltration: None Pipe Seal Cond: Sound
